Stati-CAL®

Stati BAR

Stati-CAL system:

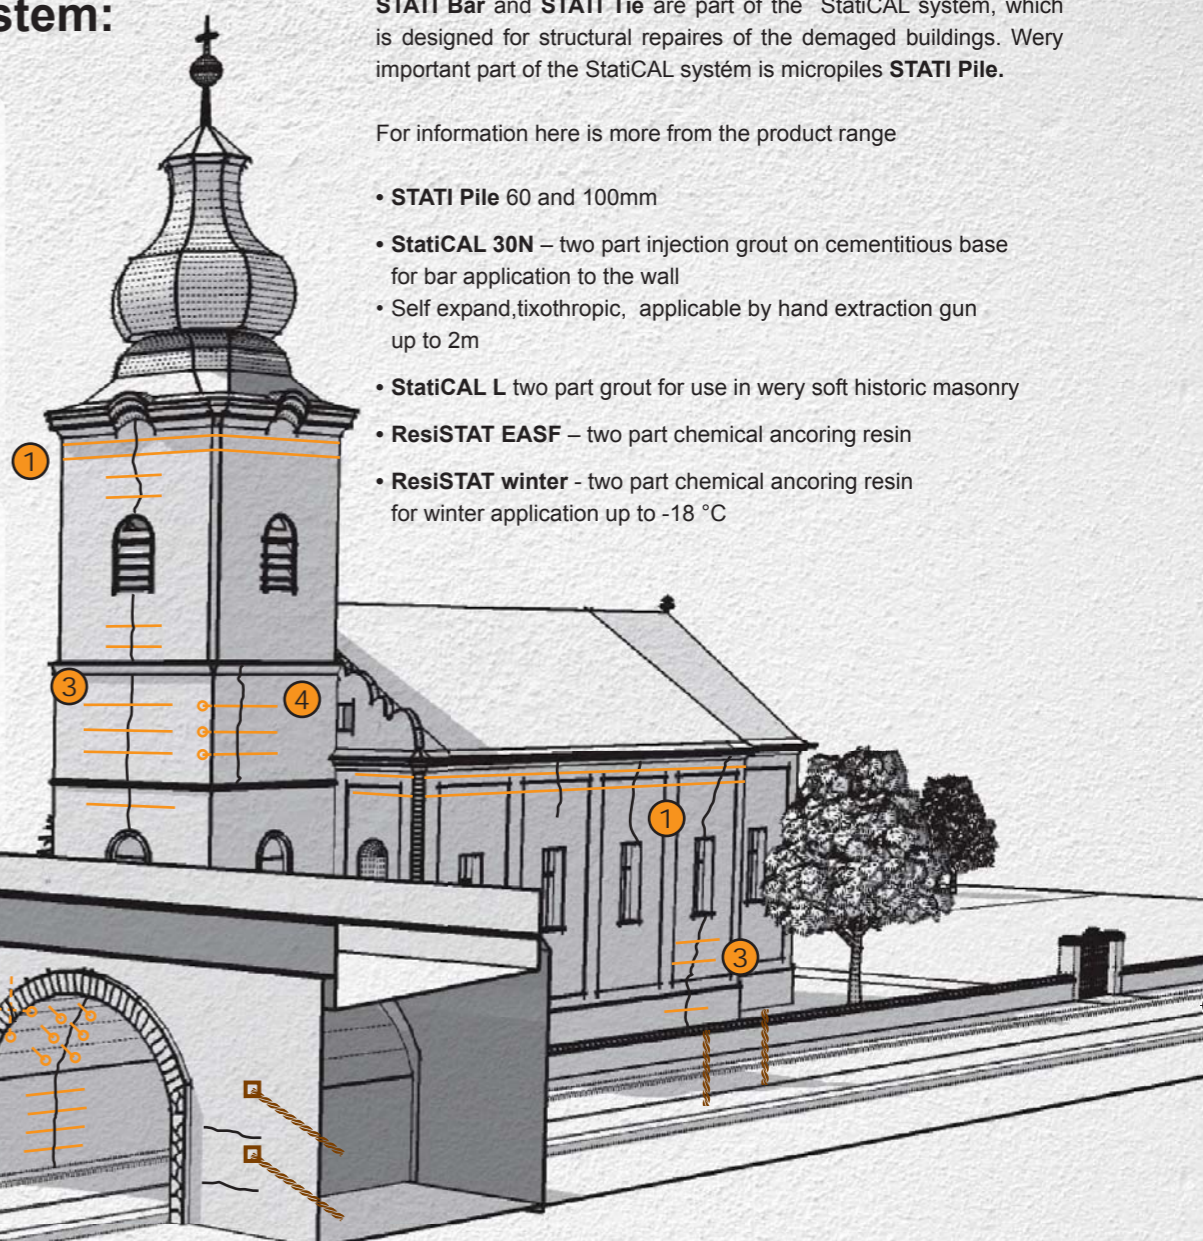
Applications of the System StatiCAL is designed for static repair of all types of buildings. From historical buildings to modern buildings, from residential through traffic.

We take as a model the shape of the basic building block of organic material and thanks to the unique technology of forming stainless steel we give shape of DNA into our DNA bars. Through this shape we ensure their unique functionality in inorganic structures, for transfer of the bar features we are using a specially designed grout.

In the production of this bar we change the inside structure of the edges. They are hardened, but the core remains soft. Thanks to these two parts are twisted against each other, this twist generates prestressed material. This is one of the major attributes of these bars. Bars are prestressed without bringing it into the building additional tension, which may cause unsuitably towards the damaged wall. Bar is tensioned by the whole length, which brings another advantage over traditional methods. Bar by whole length, which is glued to the wall reacting.

StatiBAR ties are made from stainless steel material in sections 4.5 - 6 - 8 to 10 mm, in lengths from 50mm to 10m.

Bars are installed in grooves with a width of about 10mm and a maximum drilled bores are about the size of 14mm. Slots can reach a depth of up to 140mm, it may not case of removing thick plaster, which can be historically valuable or simply do not want to do all the new plaster on the facade. On brickwork or stone facade is application to the joints.
