# TECHNOLOGIES AND APPLICATION METHODS

# *Tergomatic*

**Non-invasive dehumidifier to control rising damp**

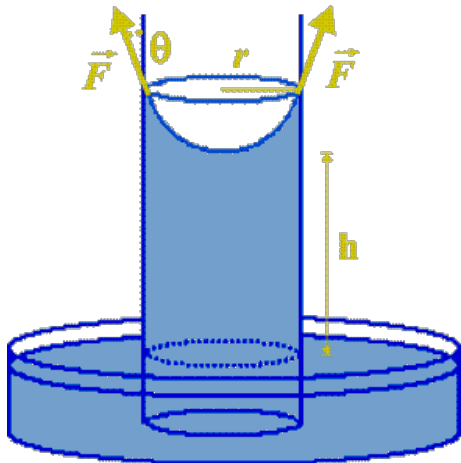
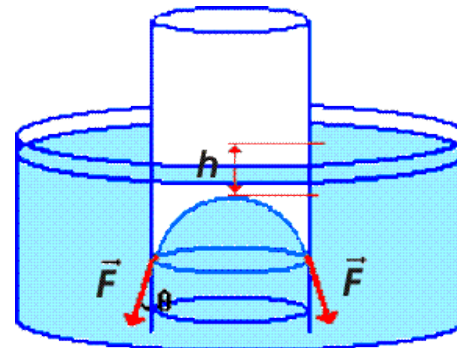
$$\gamma > 0$$

$$\gamma < 0$$

$$h = f(d)$$

diameter of capillary (mm)	height of water (mm)
2.5	25
1.5	38
1.0	52
0.5	66

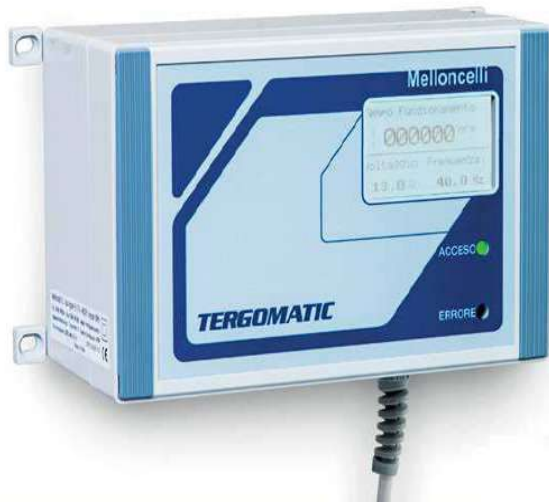
Appropriate circuits enclosed in small equipment to activate emission of an inductor electro-magnetic field which, affecting and interacting with the wall, causes it to have the same induced field that neutralises the potential of the electrical loads in the masonry work, obtaining the following results:

- **stoppage of rising damp**
- **evaporation of water in the wall**
- **surfacing of salts in the masonry work**

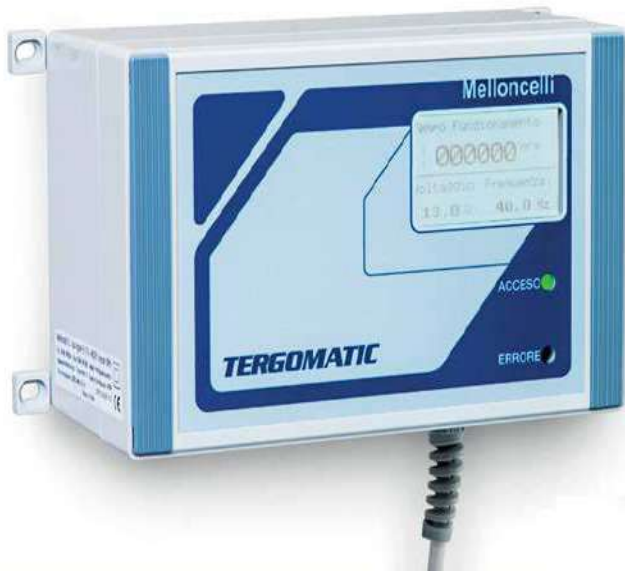
**Model DM8 (action range approx. 8 metres): m. 11 x 11 = m2. 121**

**Model DM10 (action range approx. 10 metres): m. 14 x 14 = m2. 196**

**Model DM15 (action range approx. 15 metres): m. 20 x 20 = m2. 400**

**Model DM20 (action range approx. 20 metres): m. 28 x 28 = m2. 784**

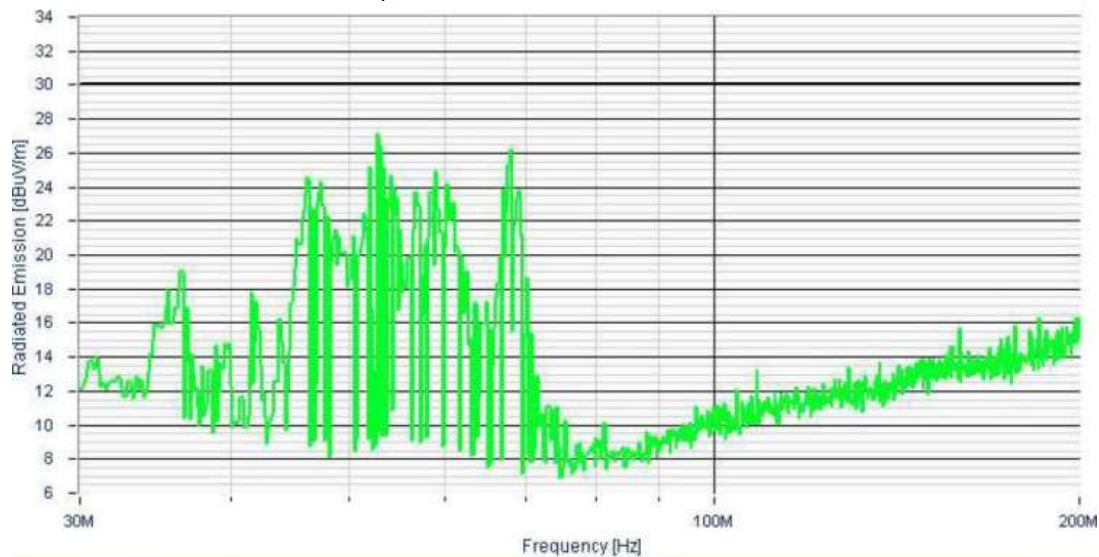
The scope of the test is to ensure electromagnetic compatibility of the equipment with the surrounding environment, measuring its electromagnetic field radiated to radio frequencies.

Radiated emission - EN 55011 - Group 1 Class B

Measurement Distance: 10 m

Antenna Orientation: Vertical

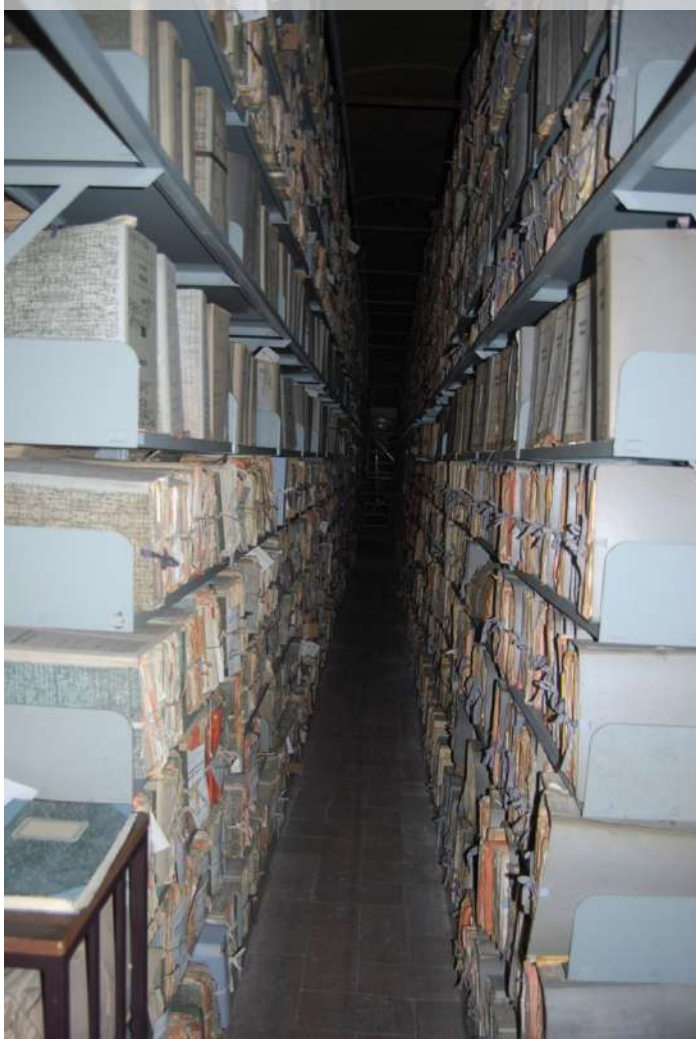
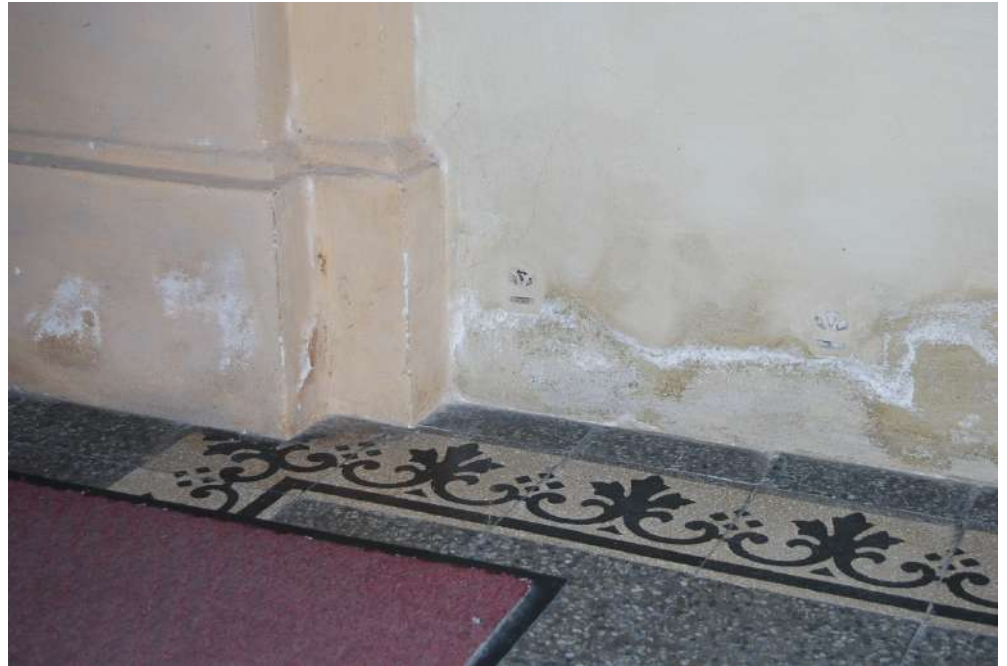
*Rising damp (2009)*

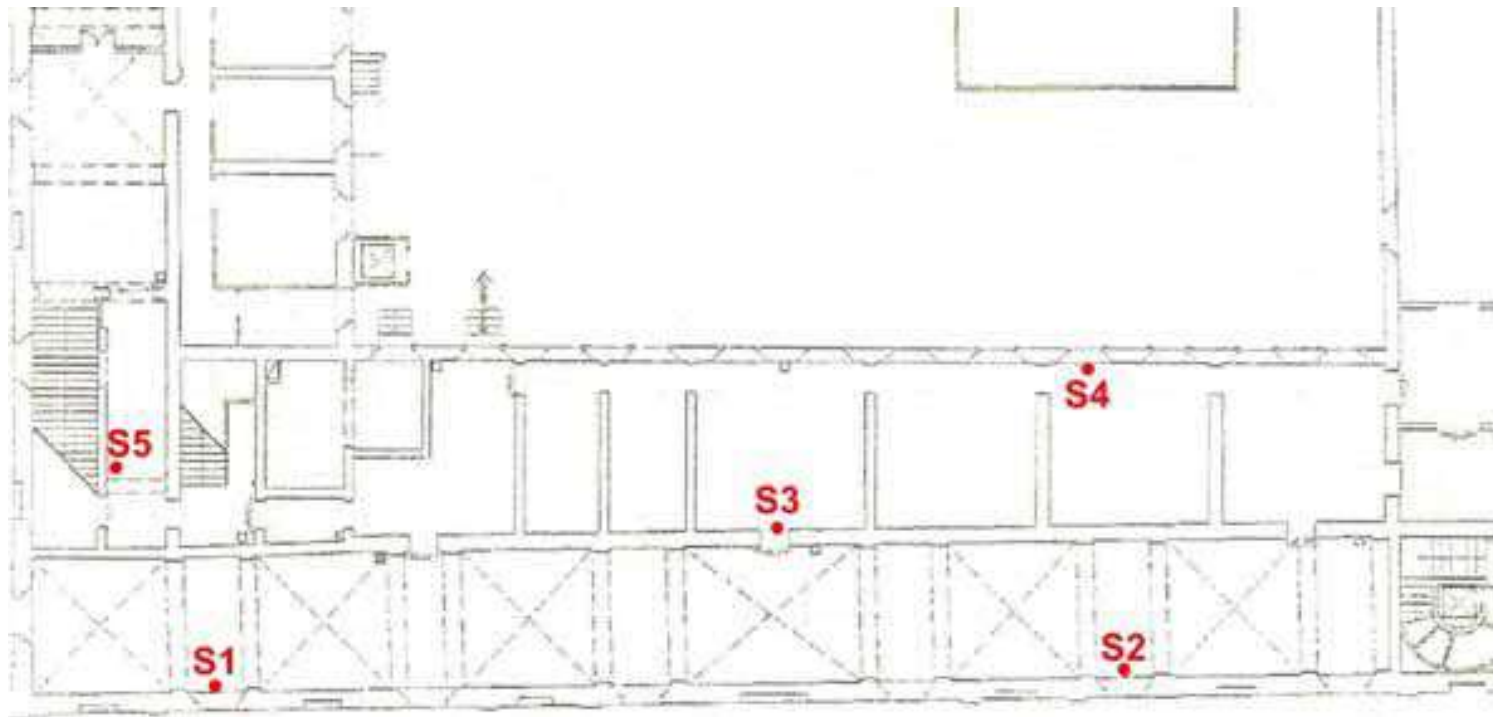
The tests were conducted over a total of 5 sample points appropriately chosen in agreement with the client and outlined in the layout (probes S1÷S5).

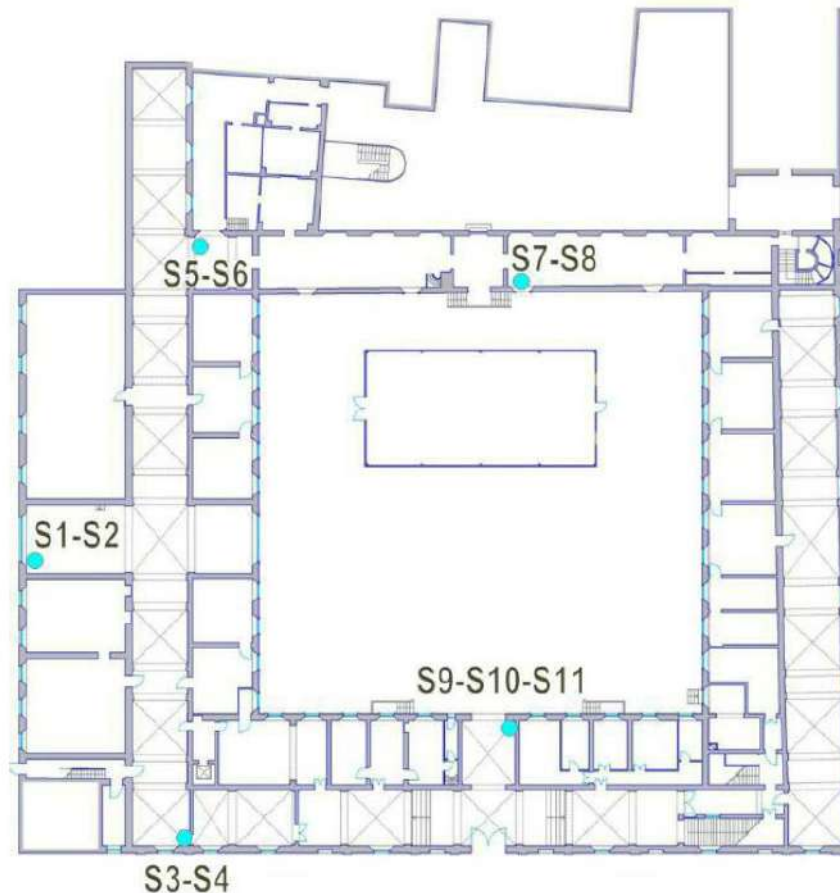
The tests were conducted over a total of 5 sample points appropriately chosen in agreement with the committee and outlined in the layout (probes S1÷S5).

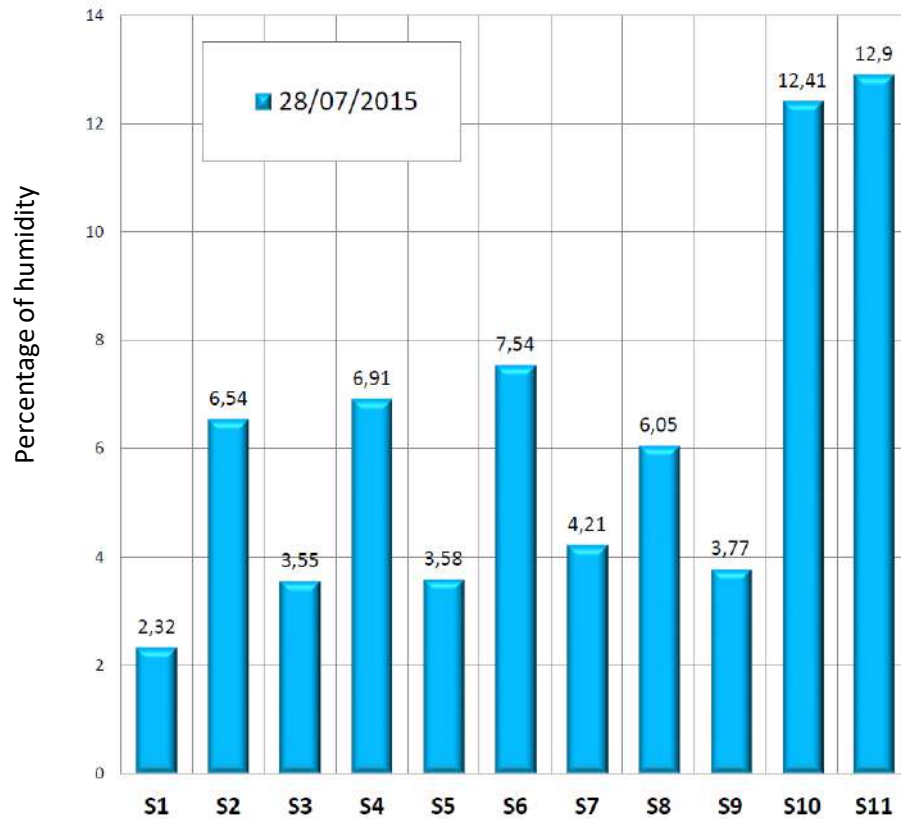
Sample data						Humidity		Soluble salts			
NAME	Date	T surface	Material	Depth	Measurement	Surface humidity	Water content	% Sulphates	% Chlorides	% Nitrates	Specific conductivity
S1	27/07/15	27.9	brick	5	60	9.1	2.32	0.1 ±0.0	0.4 ±0.1	1.0 ±0.2	71.68
S2	27/07/15	27.8	brick	5	10	12.2	6.54	0.1 ±0.0	1.0 ±0.2	0.9 ±0.2	87.74
S3	27/07/15	26.7	brick	5	60	9.7	3.55	under 0.10	1.4 ±0.3	0.9 ±0.2	89.52
S4	27/07/15	26.6	brick	4	10	8.7	6.91	2.0 ±0.1	0.9 ±0.2	0.6 ±0.1	100.00
S5	27/07/15	27.0	brick	4	60	13.7	3.58	5.1 ±0.3	0.2 ±0.0	0.2 ±0.0	118.10
S6	27/07/15	26.4	brick	4	10	8.6	7.54	0.2 ±0.0	0.3 ±0.1	under 0.01	64.08
S7	27/07/15	27.6	brick	4	60	2.5	4.21	under 0.10	0.3 ±0.1	under 0.01	NaN
S8	27/07/15	27.5	brick	4	10	2.0	6.05	under 0.10	under 0.10	under 0.01	47.06
S9	27/07/15	26.6	mixed	4	160	5.8	3.77	2.4 ±0.1	under 0.10	under 0.01	76.70
S10	27/07/15	26.0	mixed	4	60	13.9	12.41	7.4 ±0.4	0.3 ±0.1	0.6 ±0.1	177.50
S11	27/07/15	25.4	mixed	4	10	12.3	12.90	5.3 ±0.3	under 0.09	under 0.01	103.67

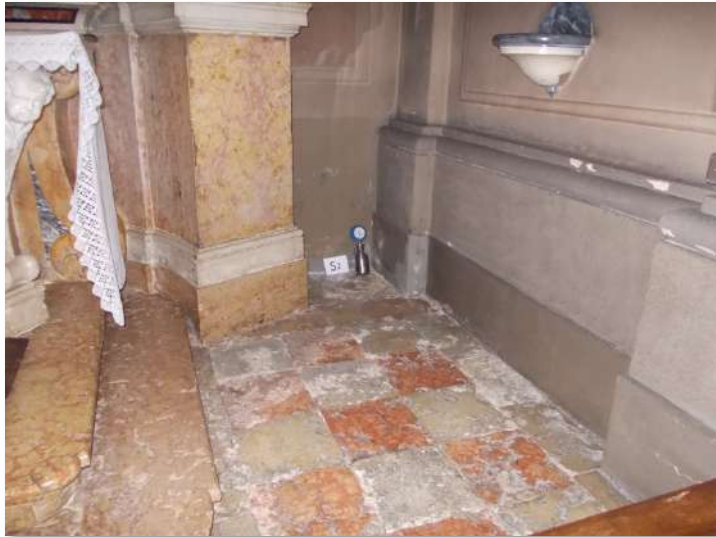
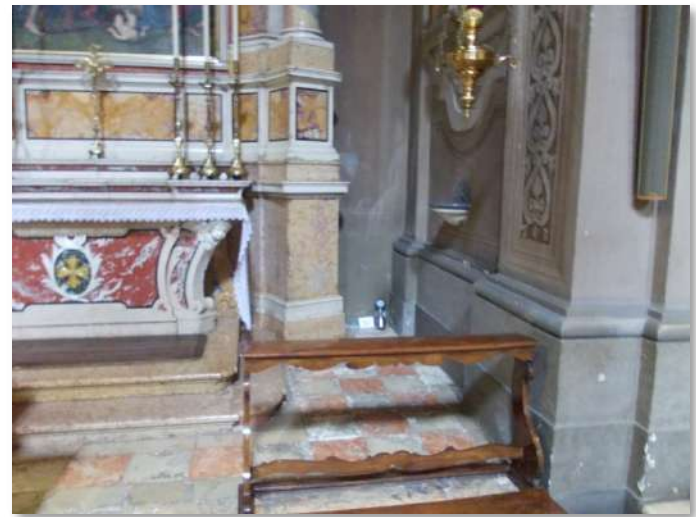
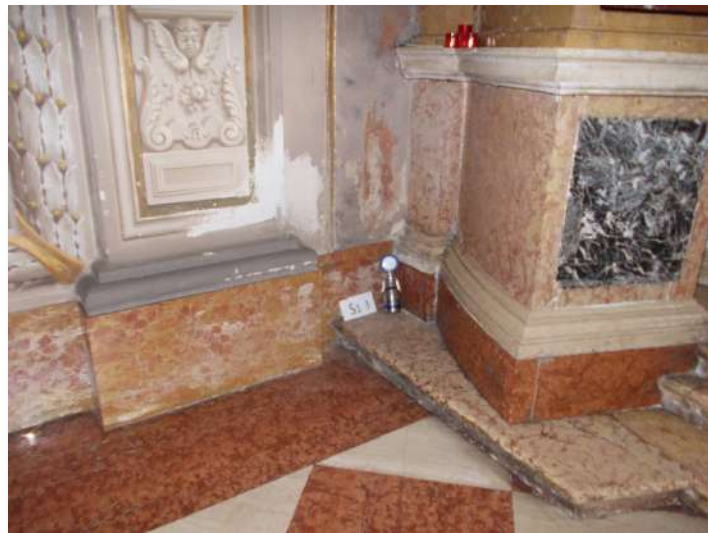
Evident rising damp

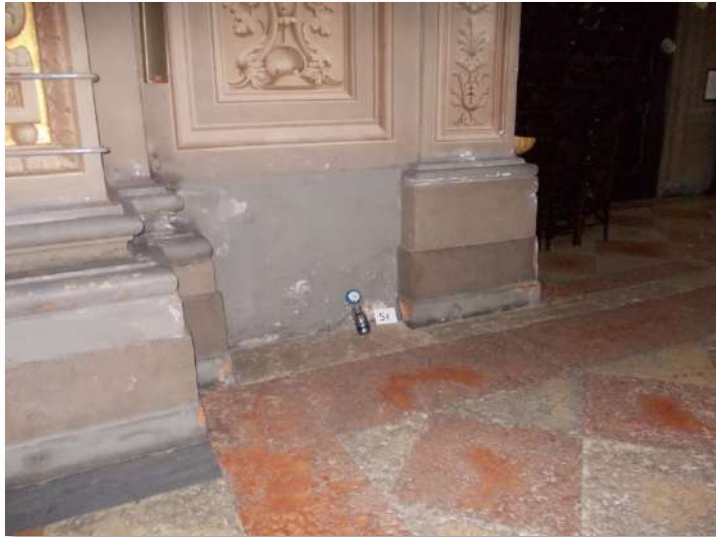
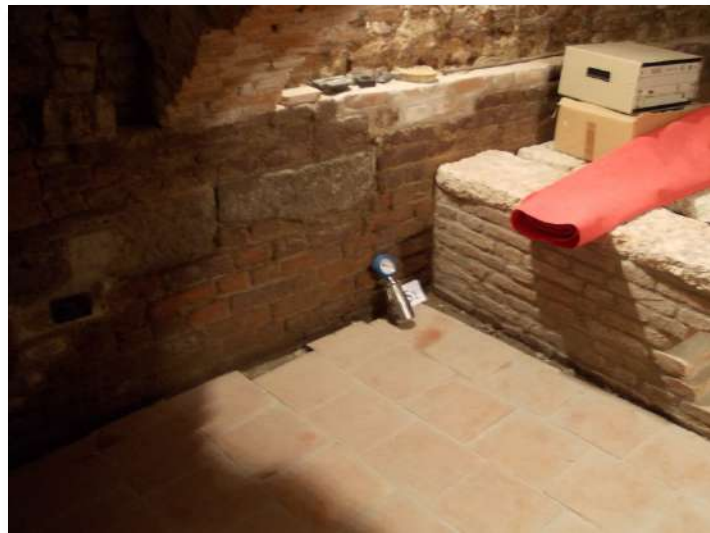
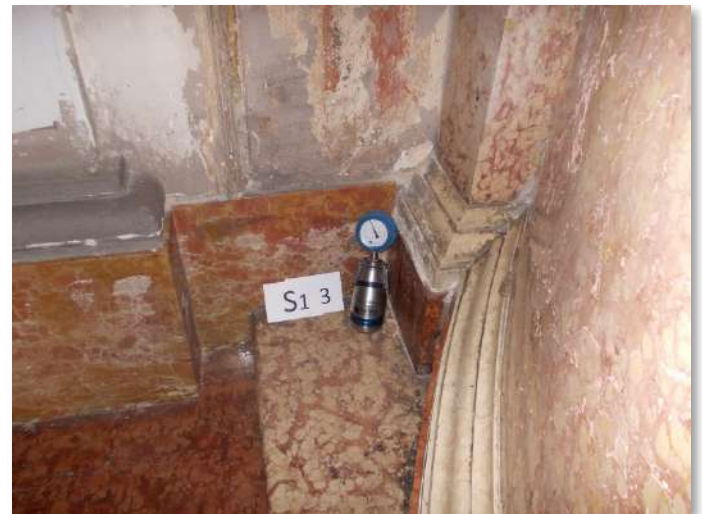
Deterioration of plaster with obvious rising damp

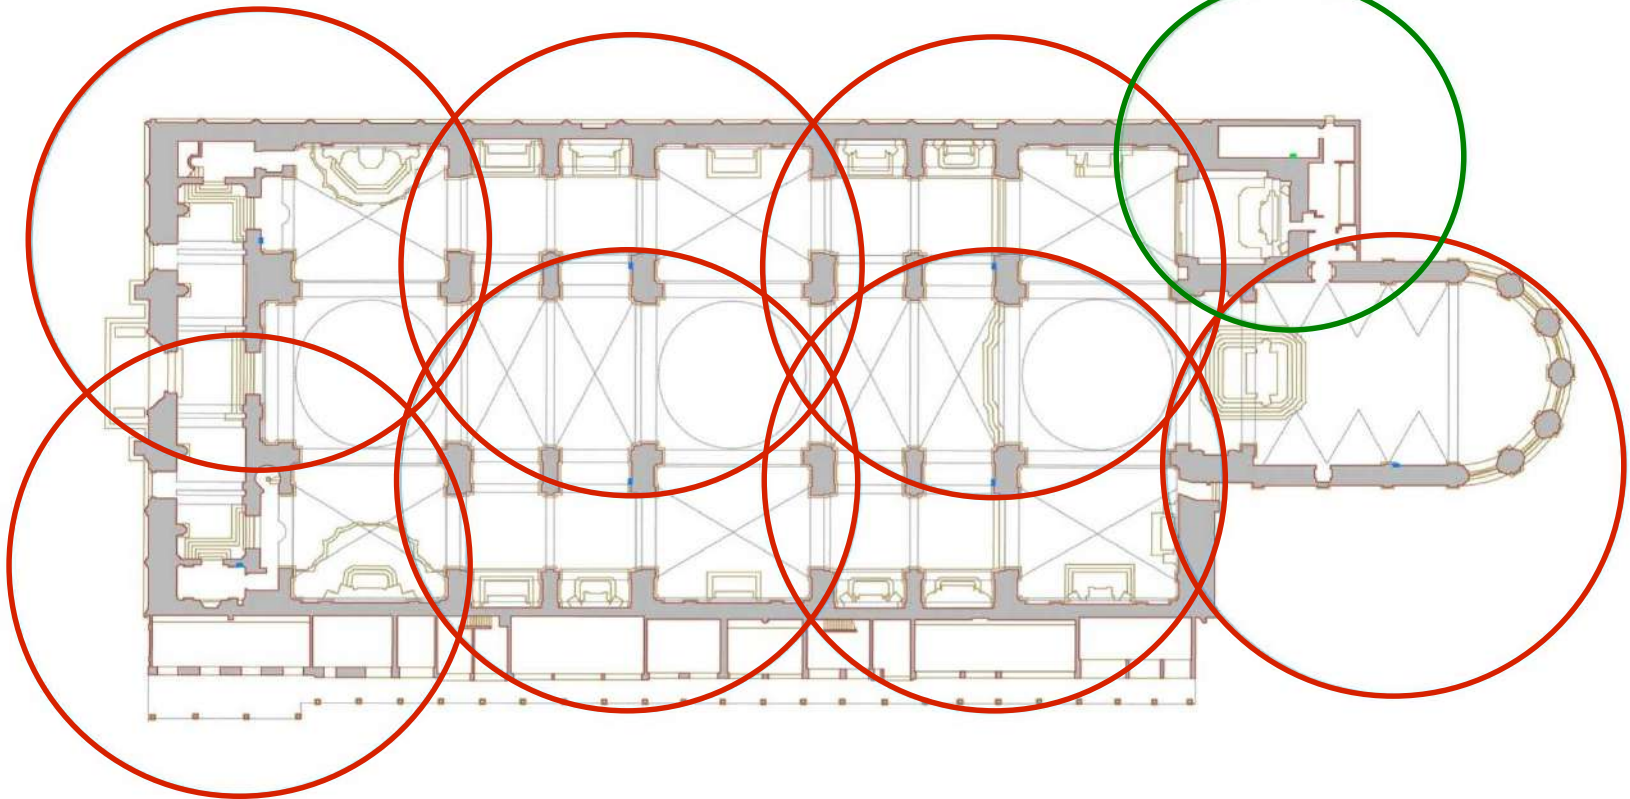
## Church Layout

**Tergomatic  
DM20**

**Tergomatic  
DM15**

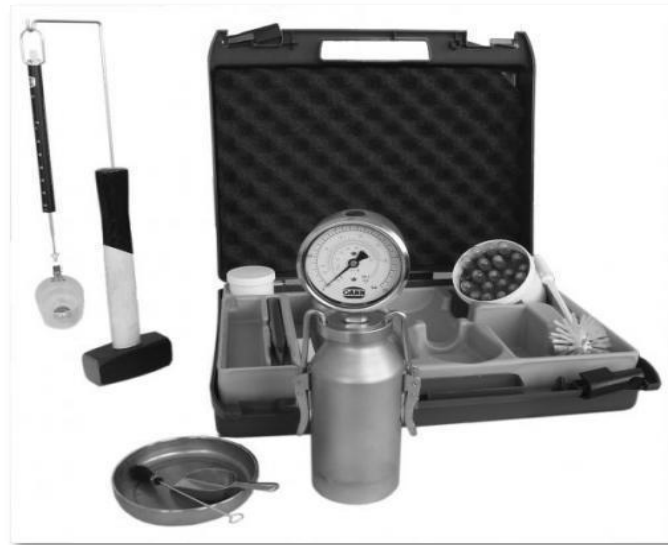
Results of analyses carried out with the carbide method

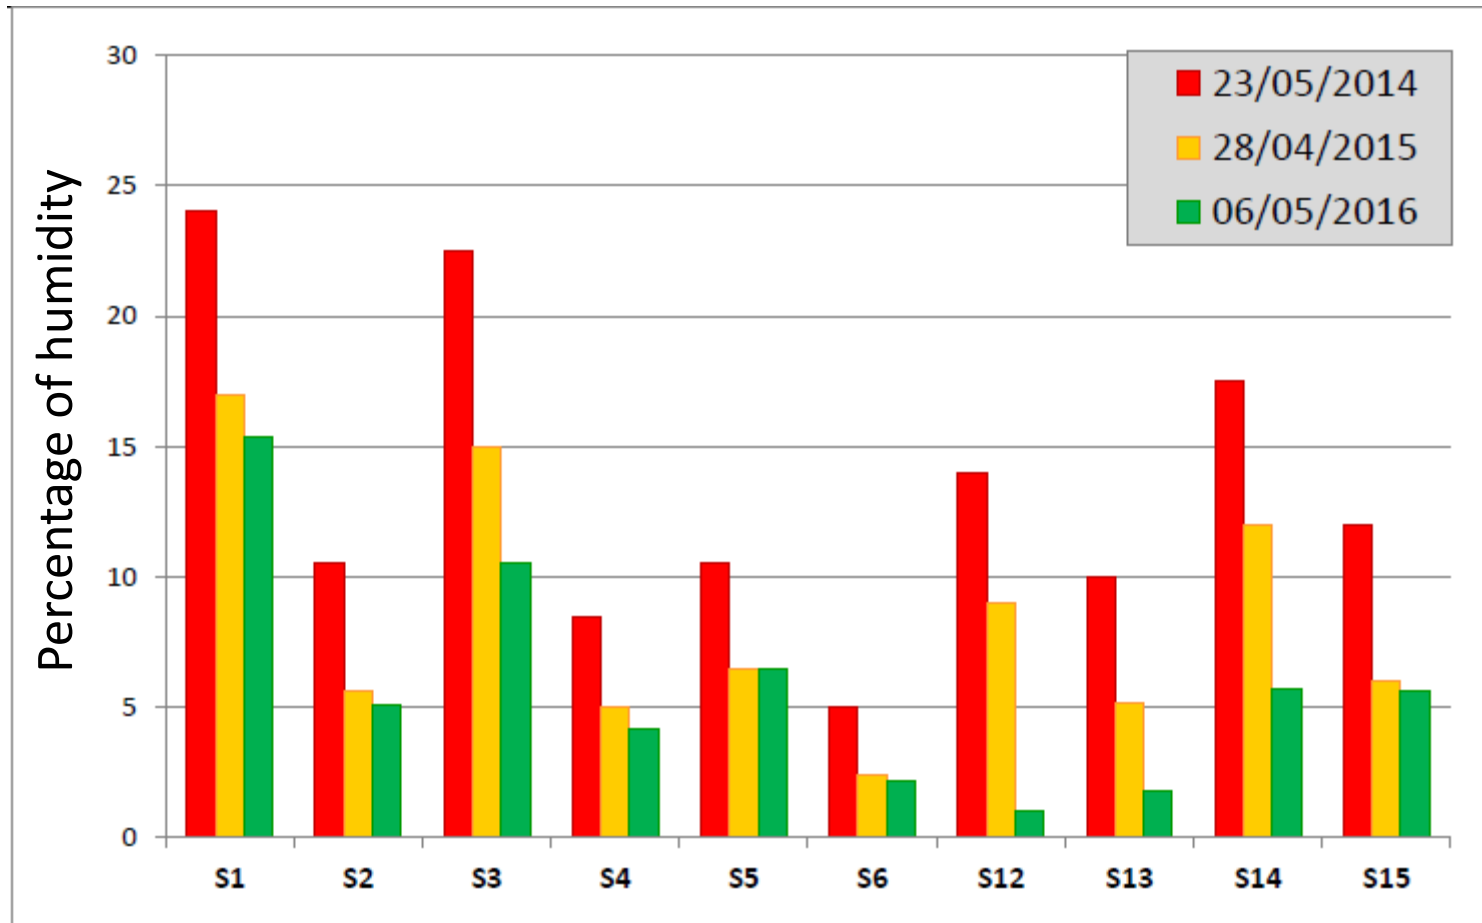
## GRAPH OF DETECTED HUMIDITY

Probing	Inspection on 23-05-2014	Inspection on 28-04-2015	Inspection on 06-05-2016	Change in humidity values
S1	24,0%	17,0%	15,4%	-35,83%
S2	10,5%	5,6%	5,1%	-51,43%
S3	22,5%	15,0%	10,5%	-53,33%
S4	8,5%	5,0%	4,2%	-50,59%
S5	10,5%	6,5%	6,5%	-38,10%
S6	5,0%	2,4%	2,2%	-56,00%
S12	14,0%	9,0%	1%	-92,86%
S13	10,0%	5,2%	1,8%	-82,00%
S14	17,5%	12,0%	5,7%	-67,43%
S15	12,0%	6,0%	5,6%	-53,33%

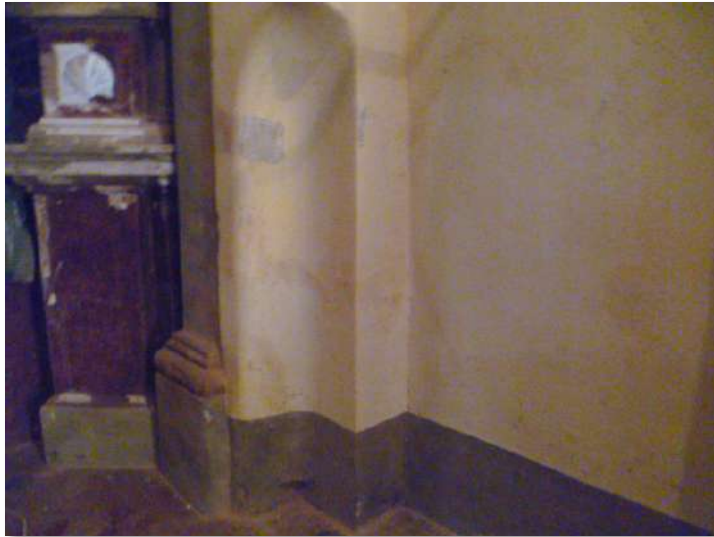
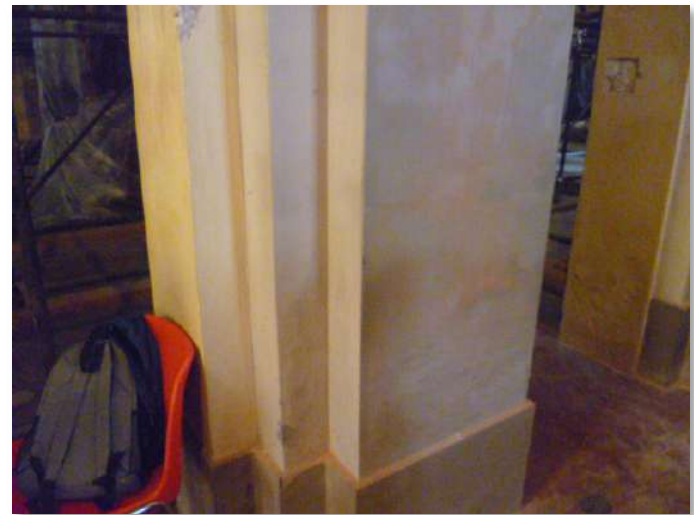
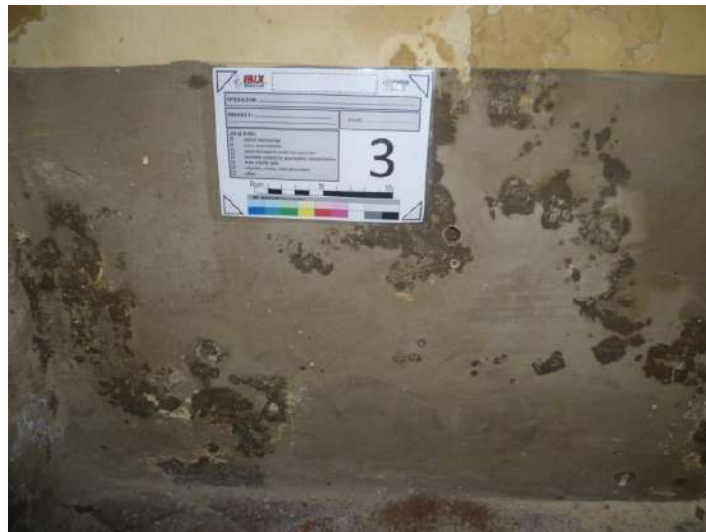
Evident rising damp

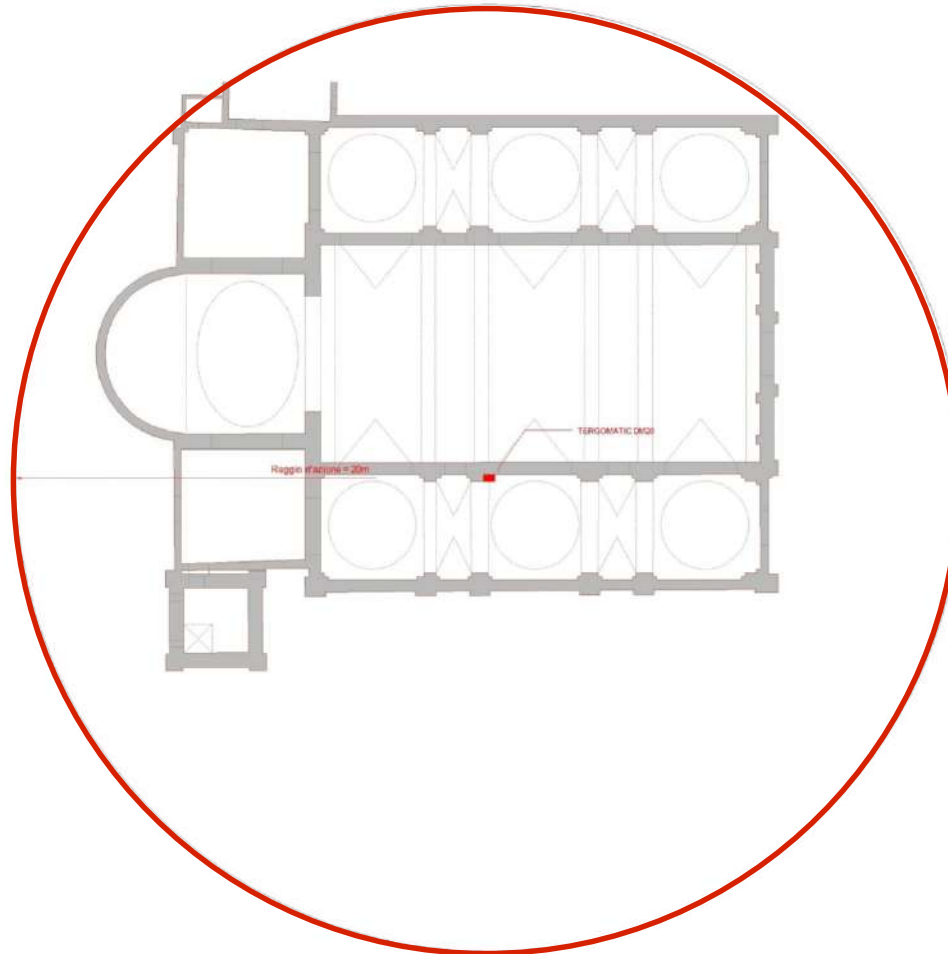
## Church Layout

**Tergomatic  
DM20**

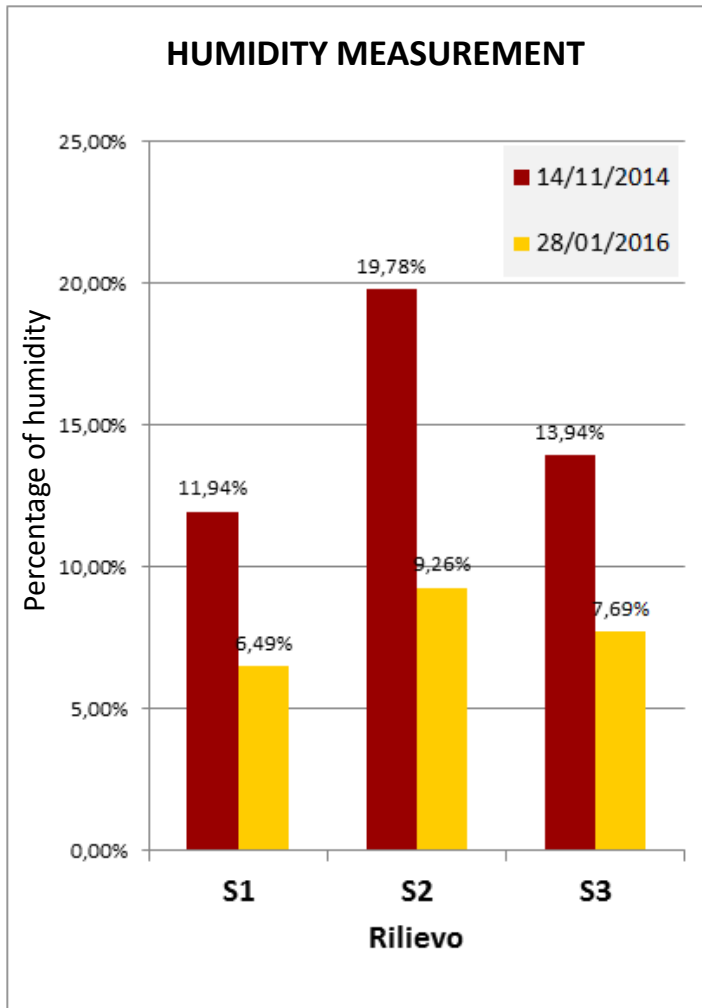
## GRAPH OF DETECTED HUMIDITY

Probing	Inspection on 14-11-2014	Inspection on 28-01-2016	Change in humidity values
S1	11,94%	6,49%	-45,68%
S2	19,78%	9,26%	-53,17%
S3	13,94%	7,69%	-44,83%

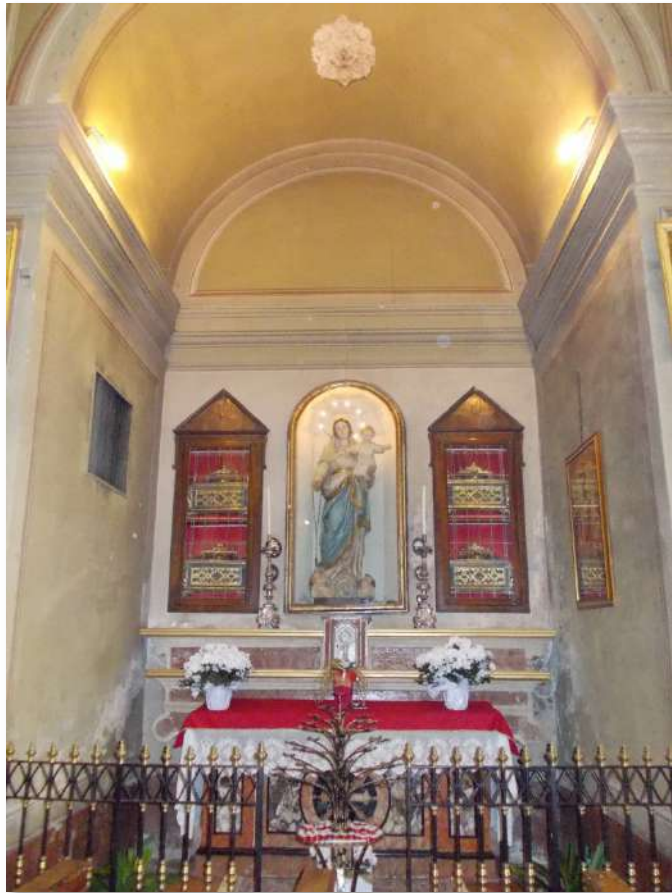
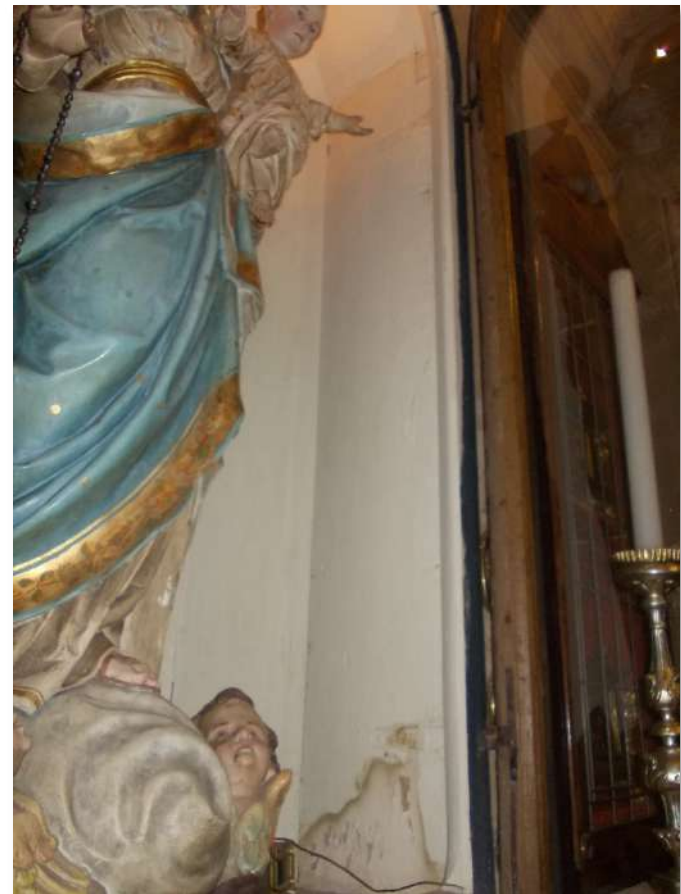
Evident rising damp

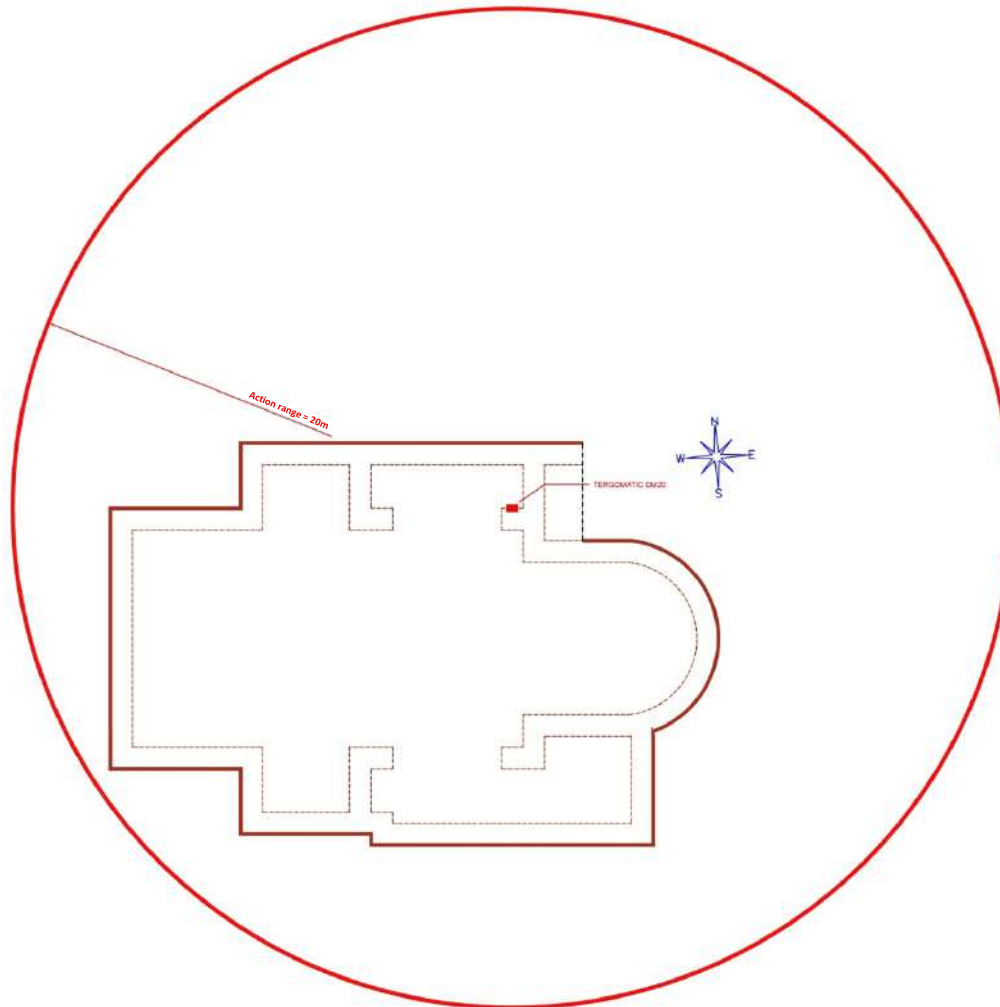
## Church Layout

**Tergomatic  
DM20**

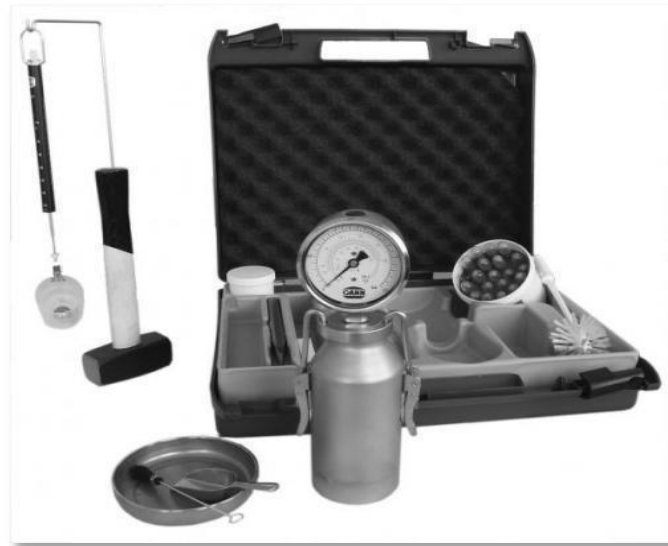
Results of analyses carried out with the carbide method

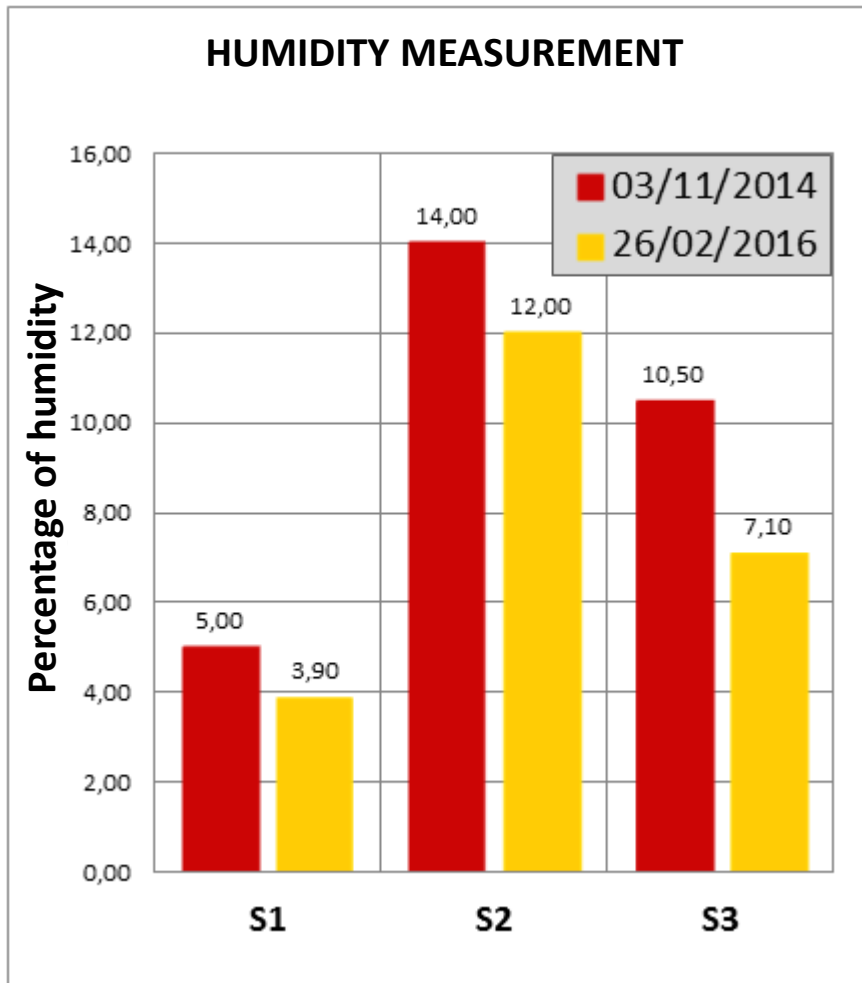
## GRAPH OF DETECTED HUMIDITY

Probing	Inspection on 03-11-2014	Inspection on 26-02-2016	Change in humidity values
S1	5%	3,9%	-22,00%
S2	14%	12%	-14,29%
S3	10,5%	7,1%	-32,38%

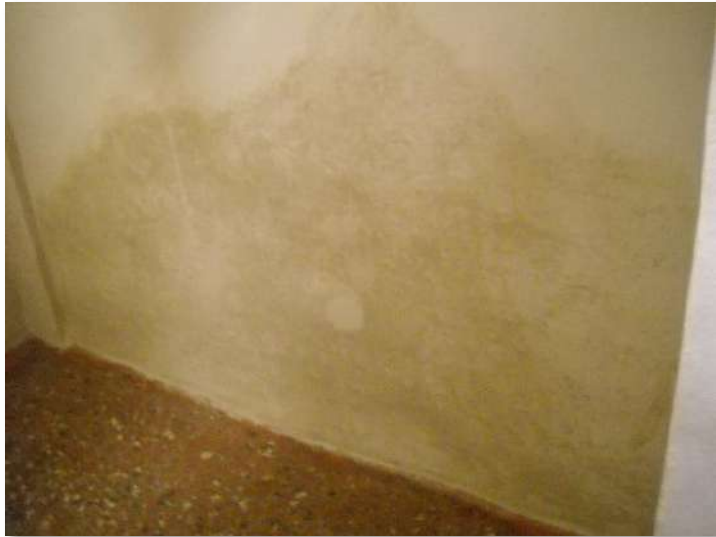
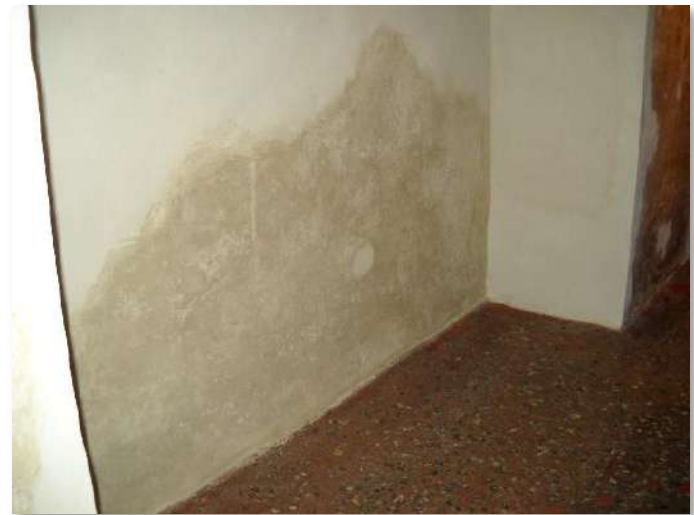
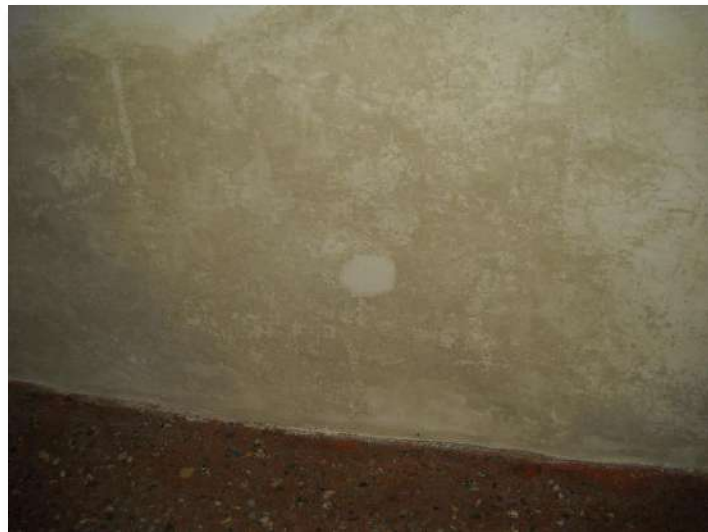
Evident rising damp

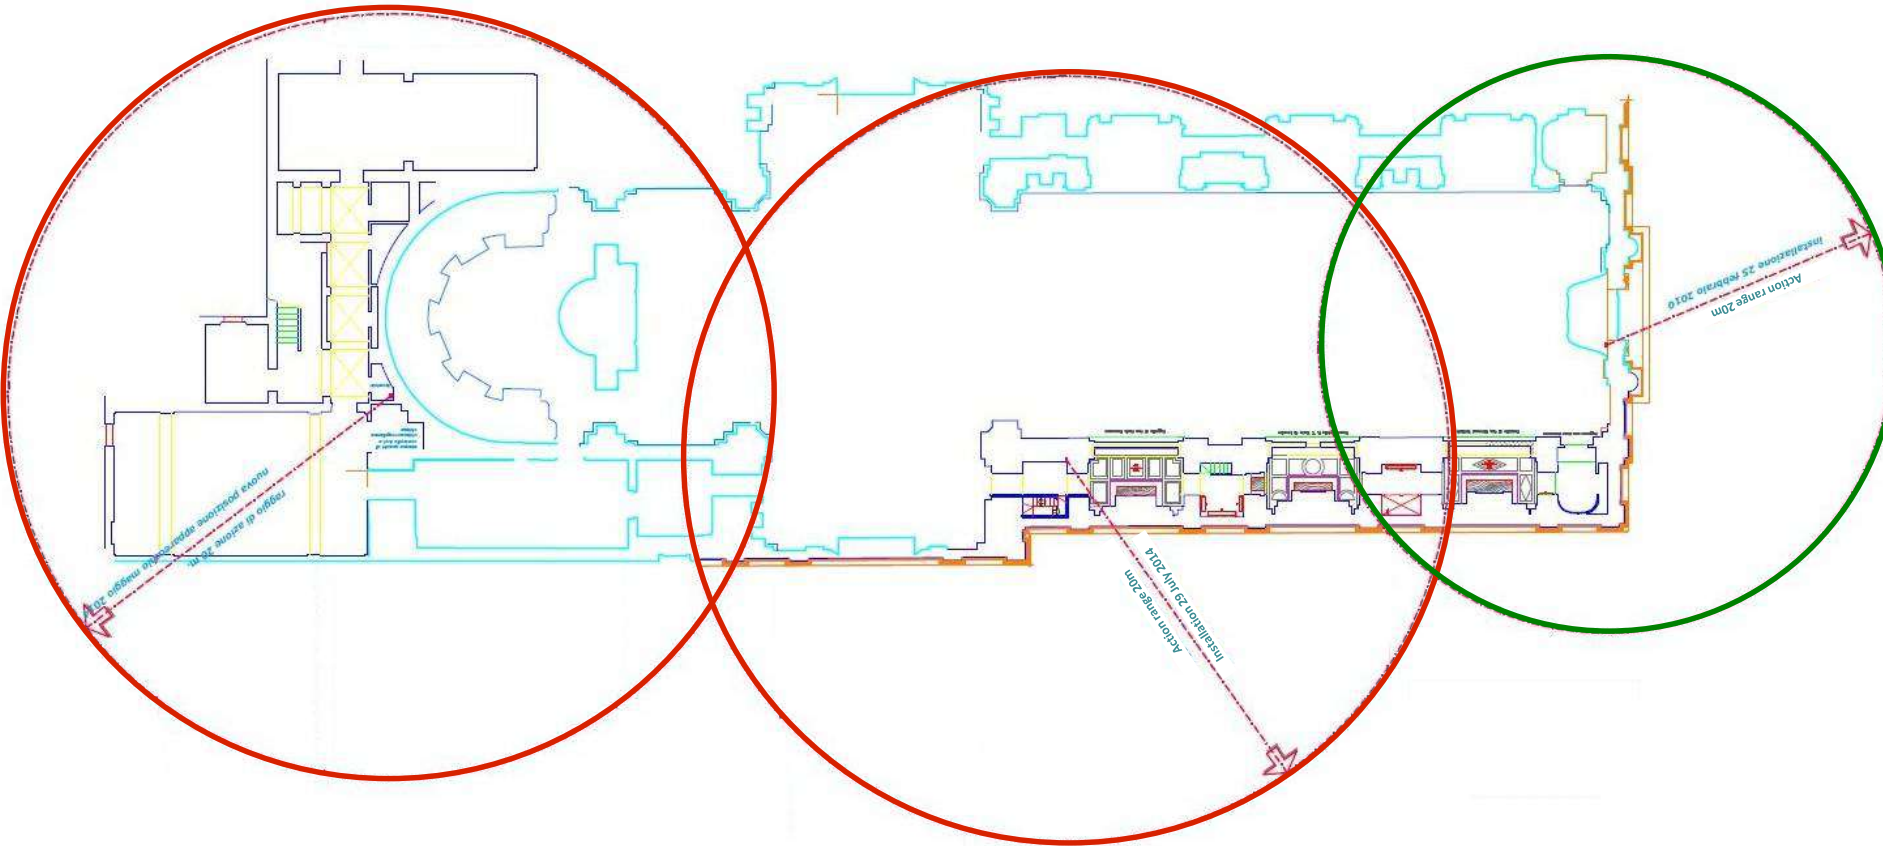
# Church Layout

**Tergomatic  
DM20 2015**

**Tergomatic  
DM15 2009**

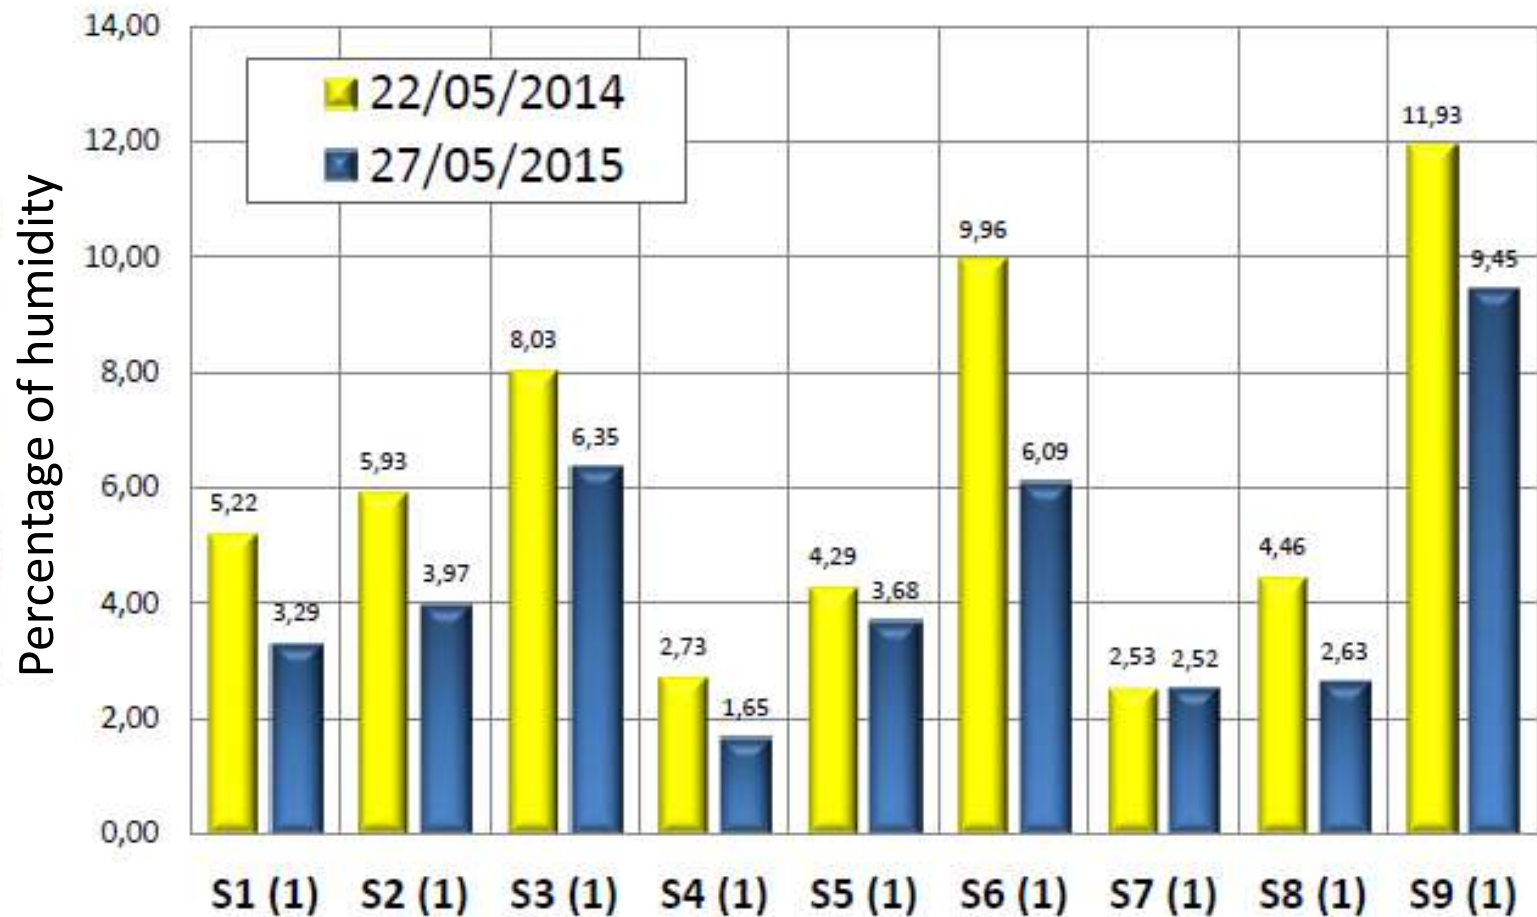
## Graph of detected humidity

### HUMIDITY MEASUREMENT (1)

<b>Probing</b>	<b>Inspection on 22-05-2014</b>	<b>Inspection on 27-05-2015</b>	<b>Change in humidity values</b>
S1 (1)	5,22%	3,29%	-36,97%
S2 (1)	5,93%	3,97%	-33,05%
S3 (1)	8,03%	6,35%	-20,92%
S4 (1)	2,73%	1,65%	-39,56%
S5 (1)	4,29%	3,68%	-14,22%
S6 (1)	9,96%	6,09%	-38,86%
S7 (1)	2,53%	2,52%	-0,40%
S8 (1)	4,46%	2,63%	-41,03%
S9 (1)	11,93%	9,45%	-20,79%
