# TECHNOLOGIES AND APPLICATION METHODS

**Roberto Cigarini**

# *Tergomatic*

**Non-invasive dehumidifier to control rising damp**

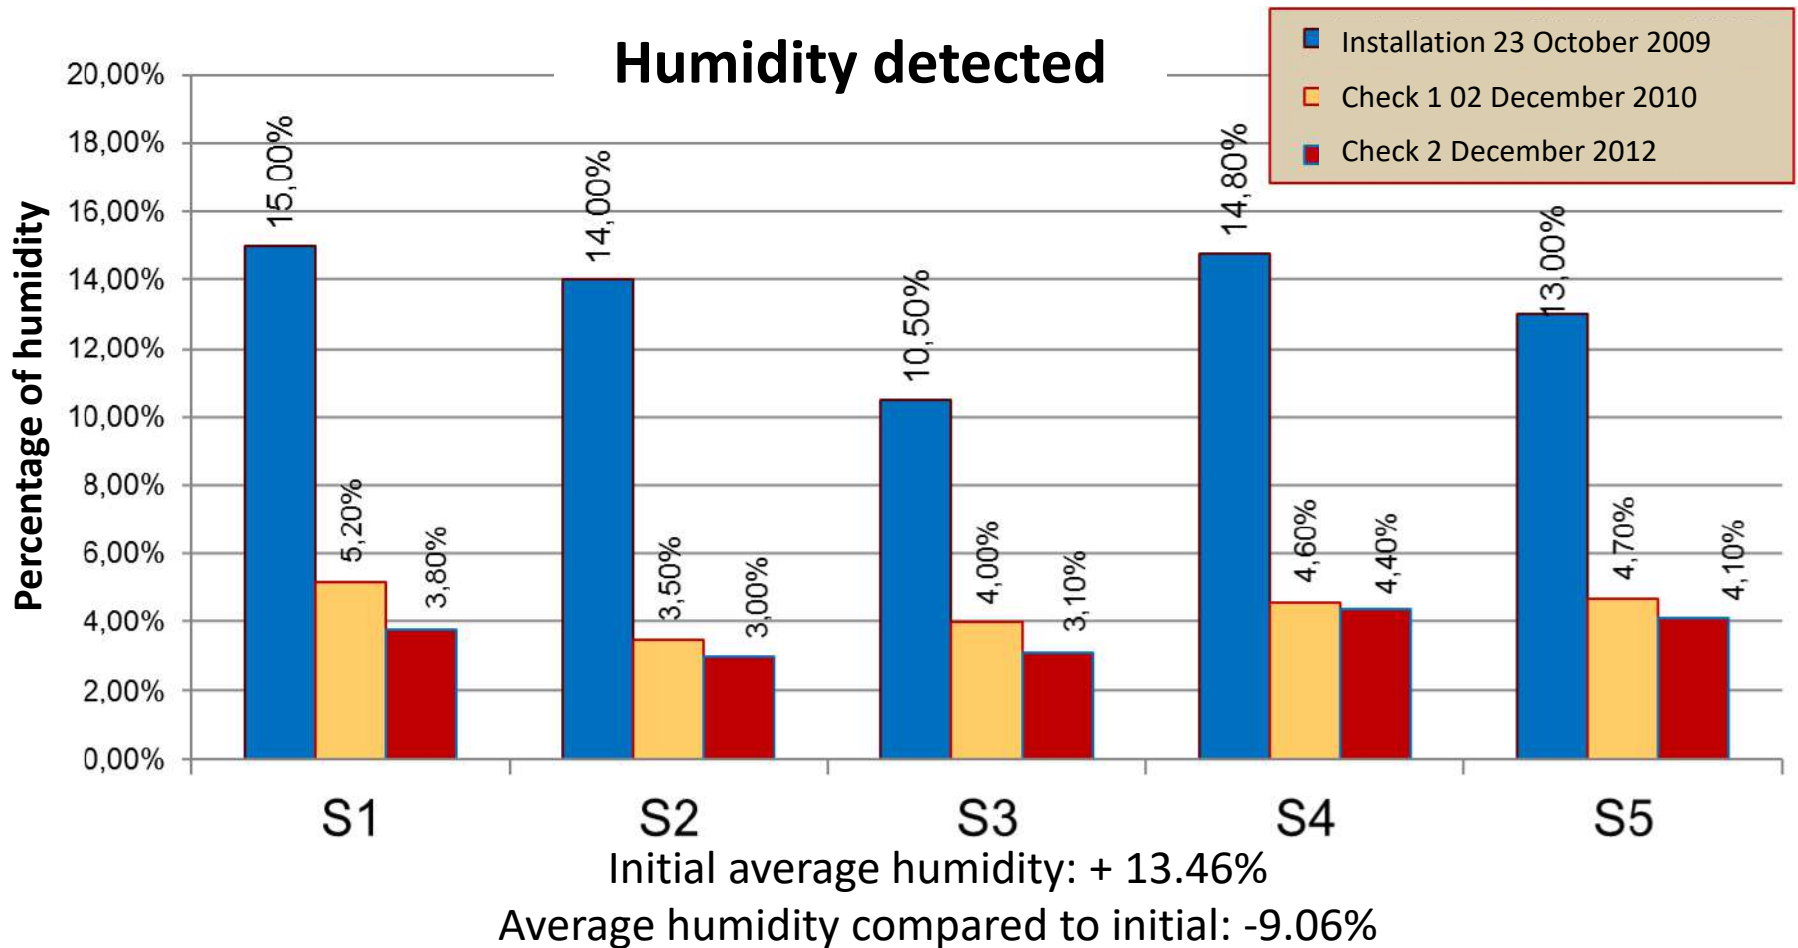
# DATA PROCESSING (2009-2012)

## Results of tests

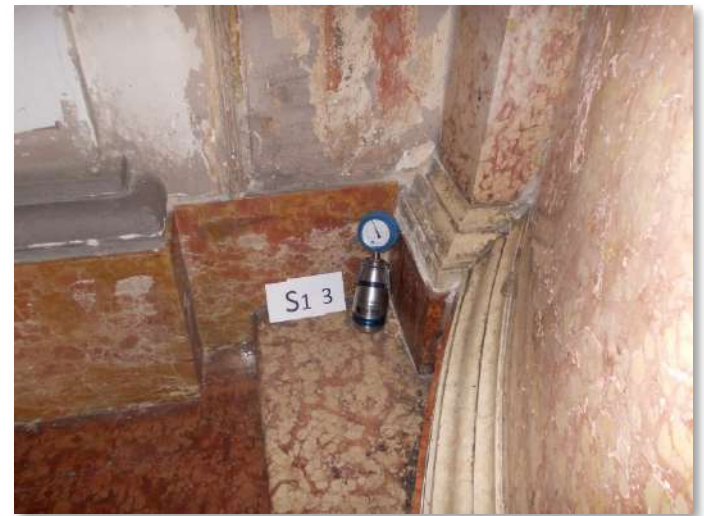
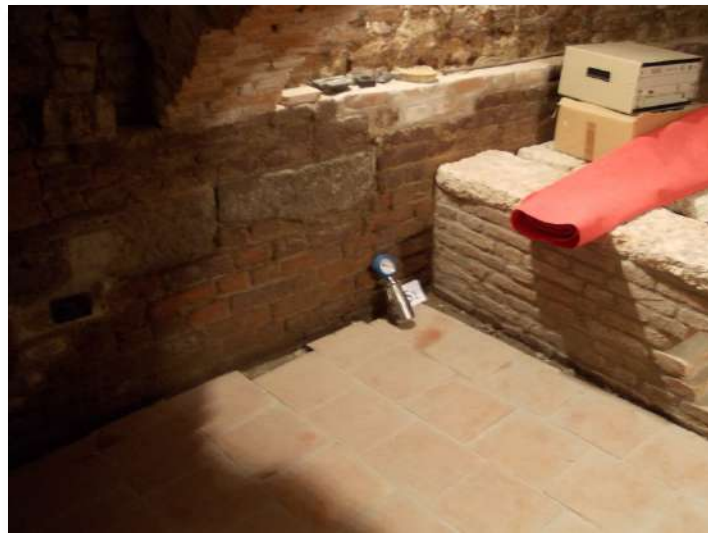
Deterioration of plaster with obvious rising damp

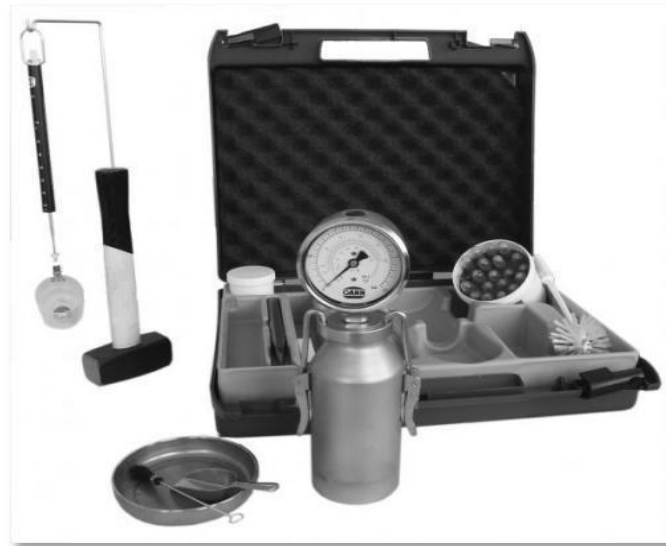
Results of analyses carried out with the carbide method

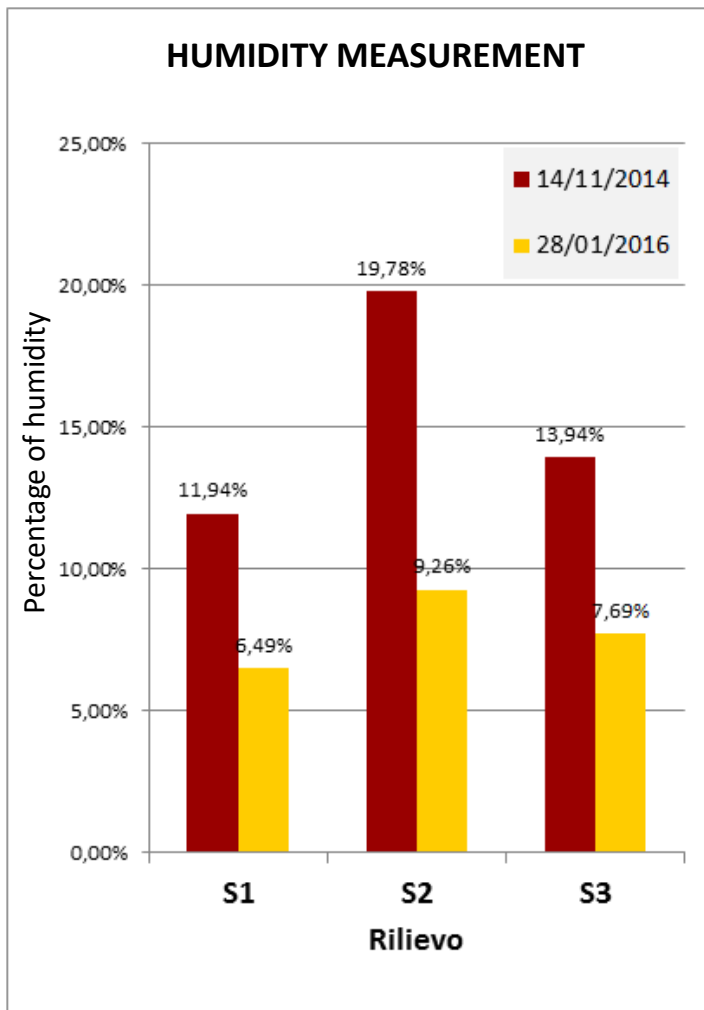
## GRAPH OF DETECTED HUMIDITY

Probing	Inspection on 14-11-2014	Inspection on 28-01-2016	Change in humidity values
S1	11,94%	6,49%	-45,68%
S2	19,78%	9,26%	-53,17%
S3	13,94%	7,69%	-44,83%

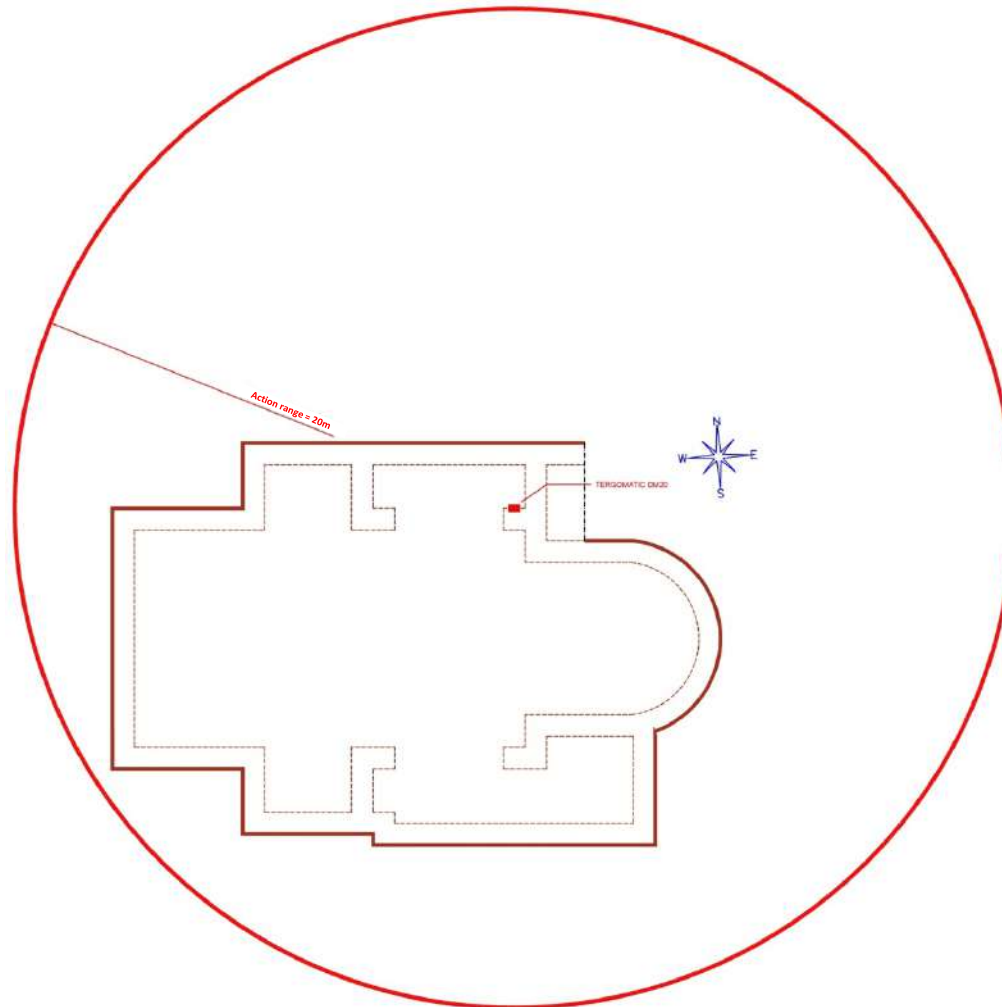
## Church Layout

**Tergomatic  
DM20**

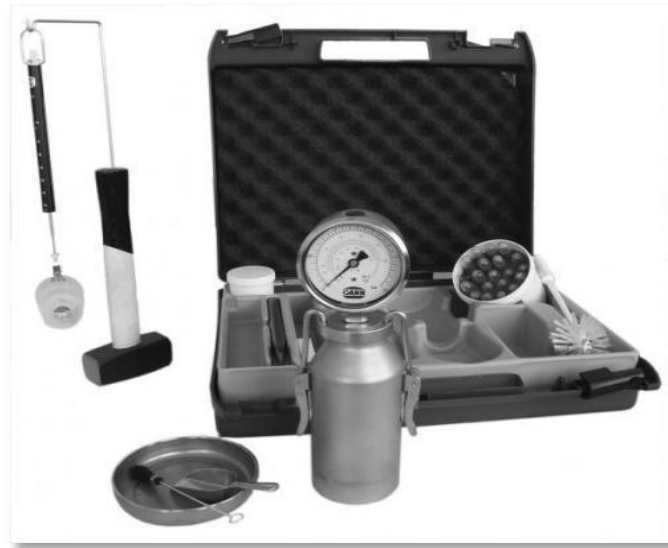
Results of analyses carried out with the carbide method

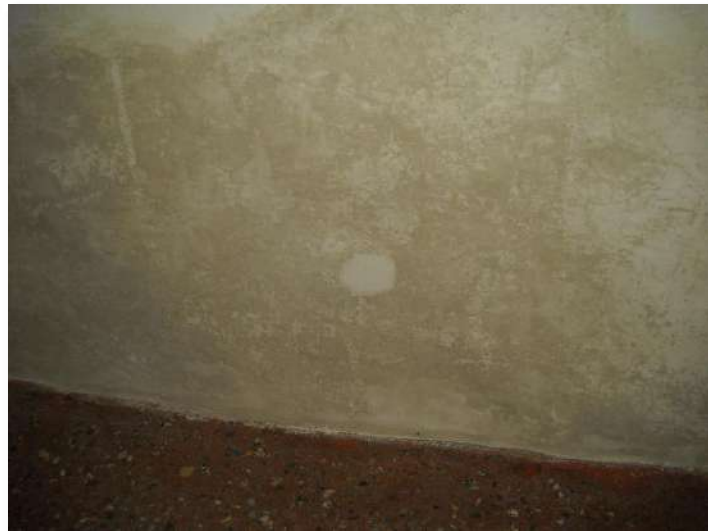
Evident rising damp
